NASA TM X-73947

CONCORDE NOISE-INDUCED BUILDING VIBRATIONS
MONTGOMERY COUNTY, MARYLAND - REPORT NO. 3

Staff-Langley Research Center

August 1976

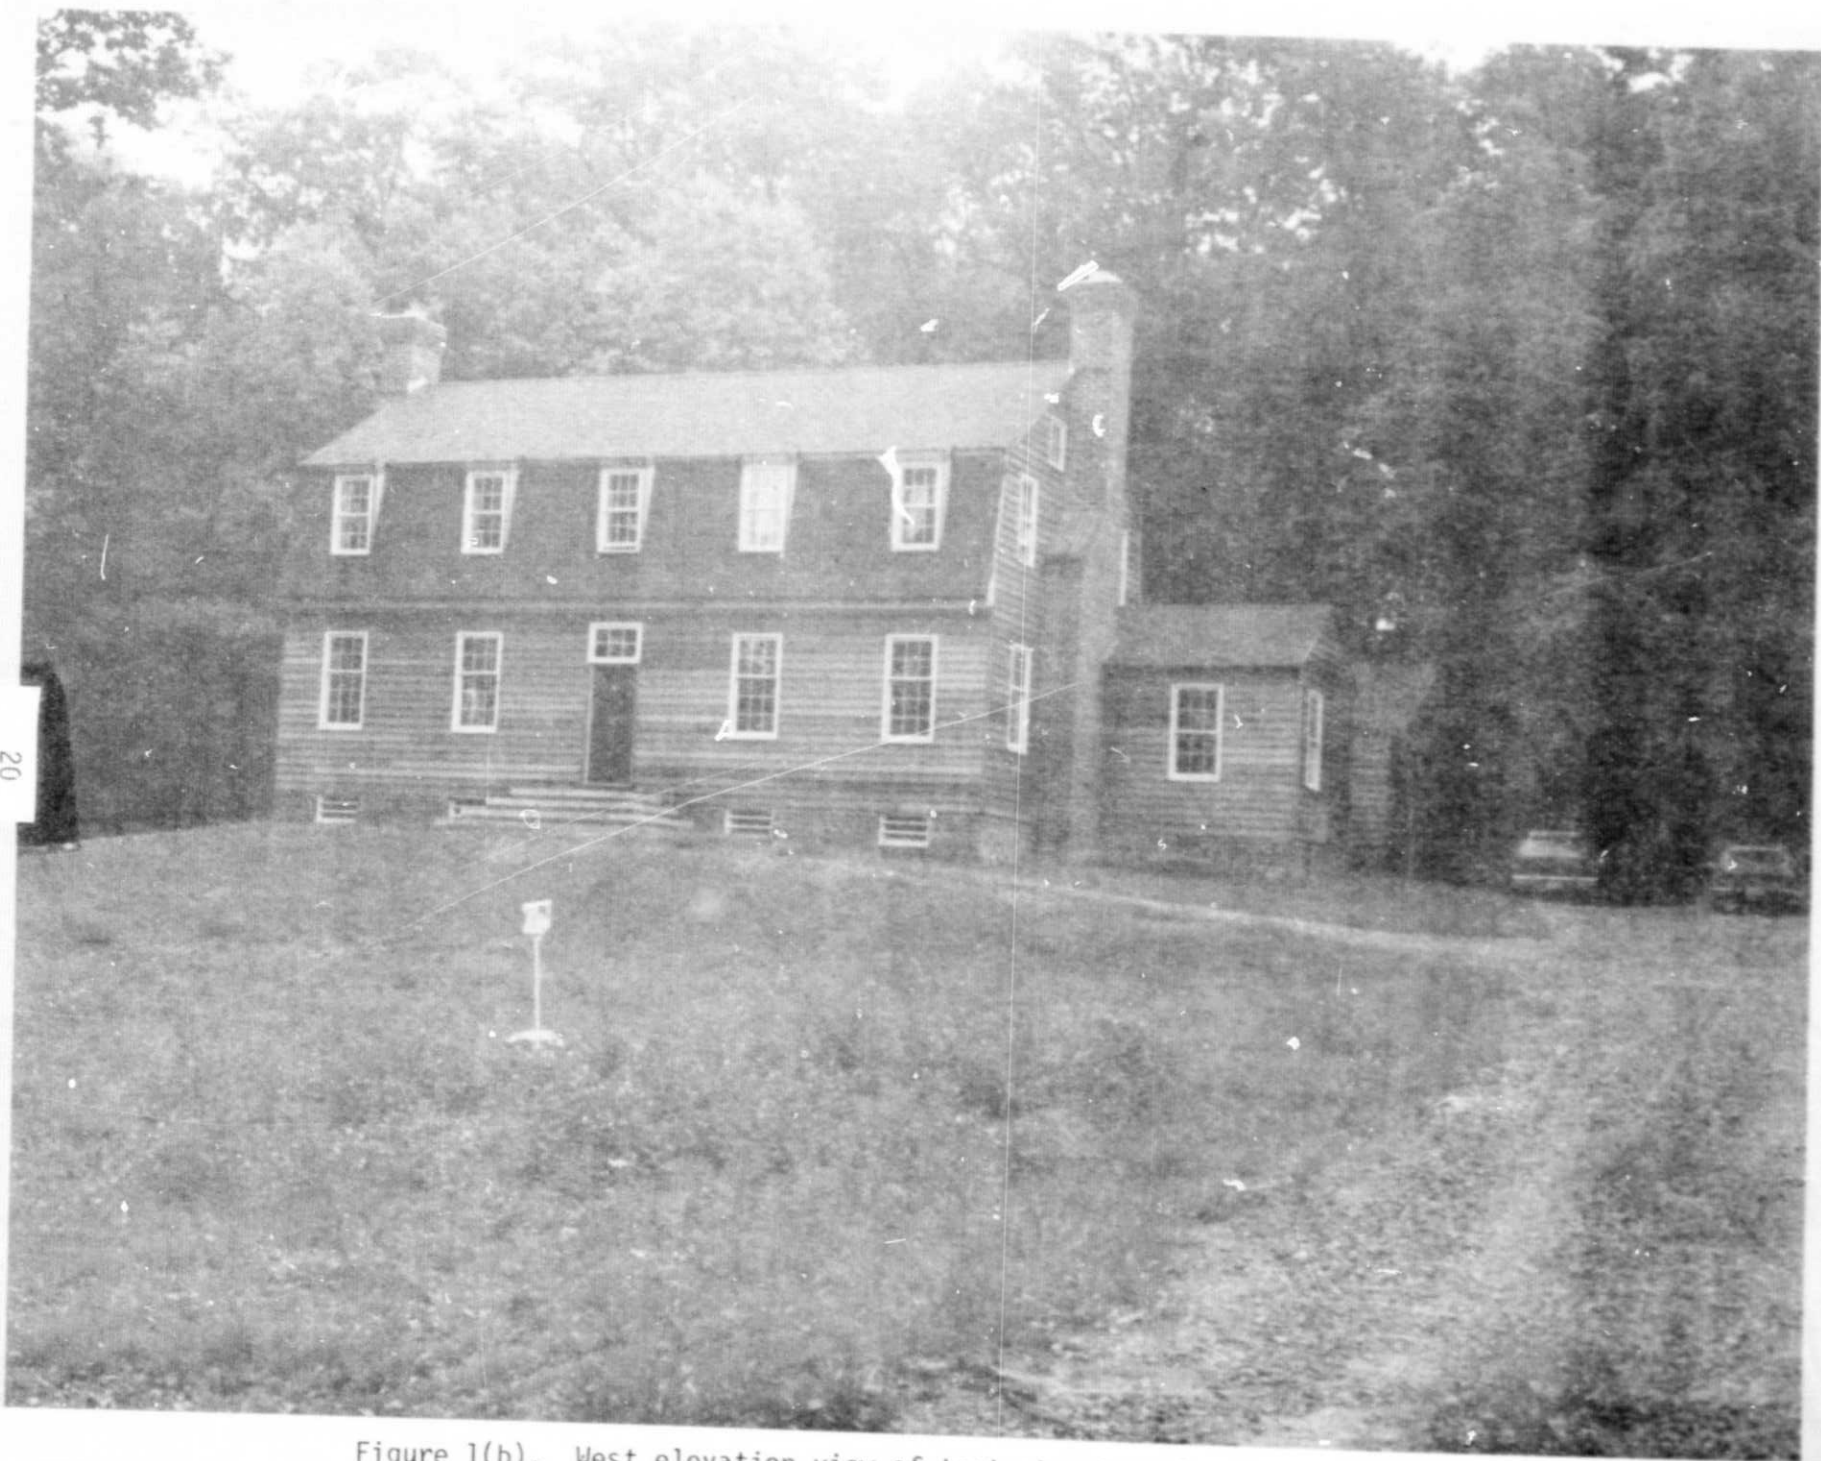
Figure 1(b). West elevation view of test structure 1.

Test structure 1.- Figure 1(b) is a photo of the west face of the recently constructed two-story "Williamsburg" style frame structure, which is situated on a west facing slope of a knoll in wooded surroundings. A sketch of the plan view of the house is provided in figure 1(c). The house is of typical wood frame construction with the exception of styrofoam insulation which was used in lieu of weatherboard before the exterior was sheathed with redwood siding. The interior walls of the house are of

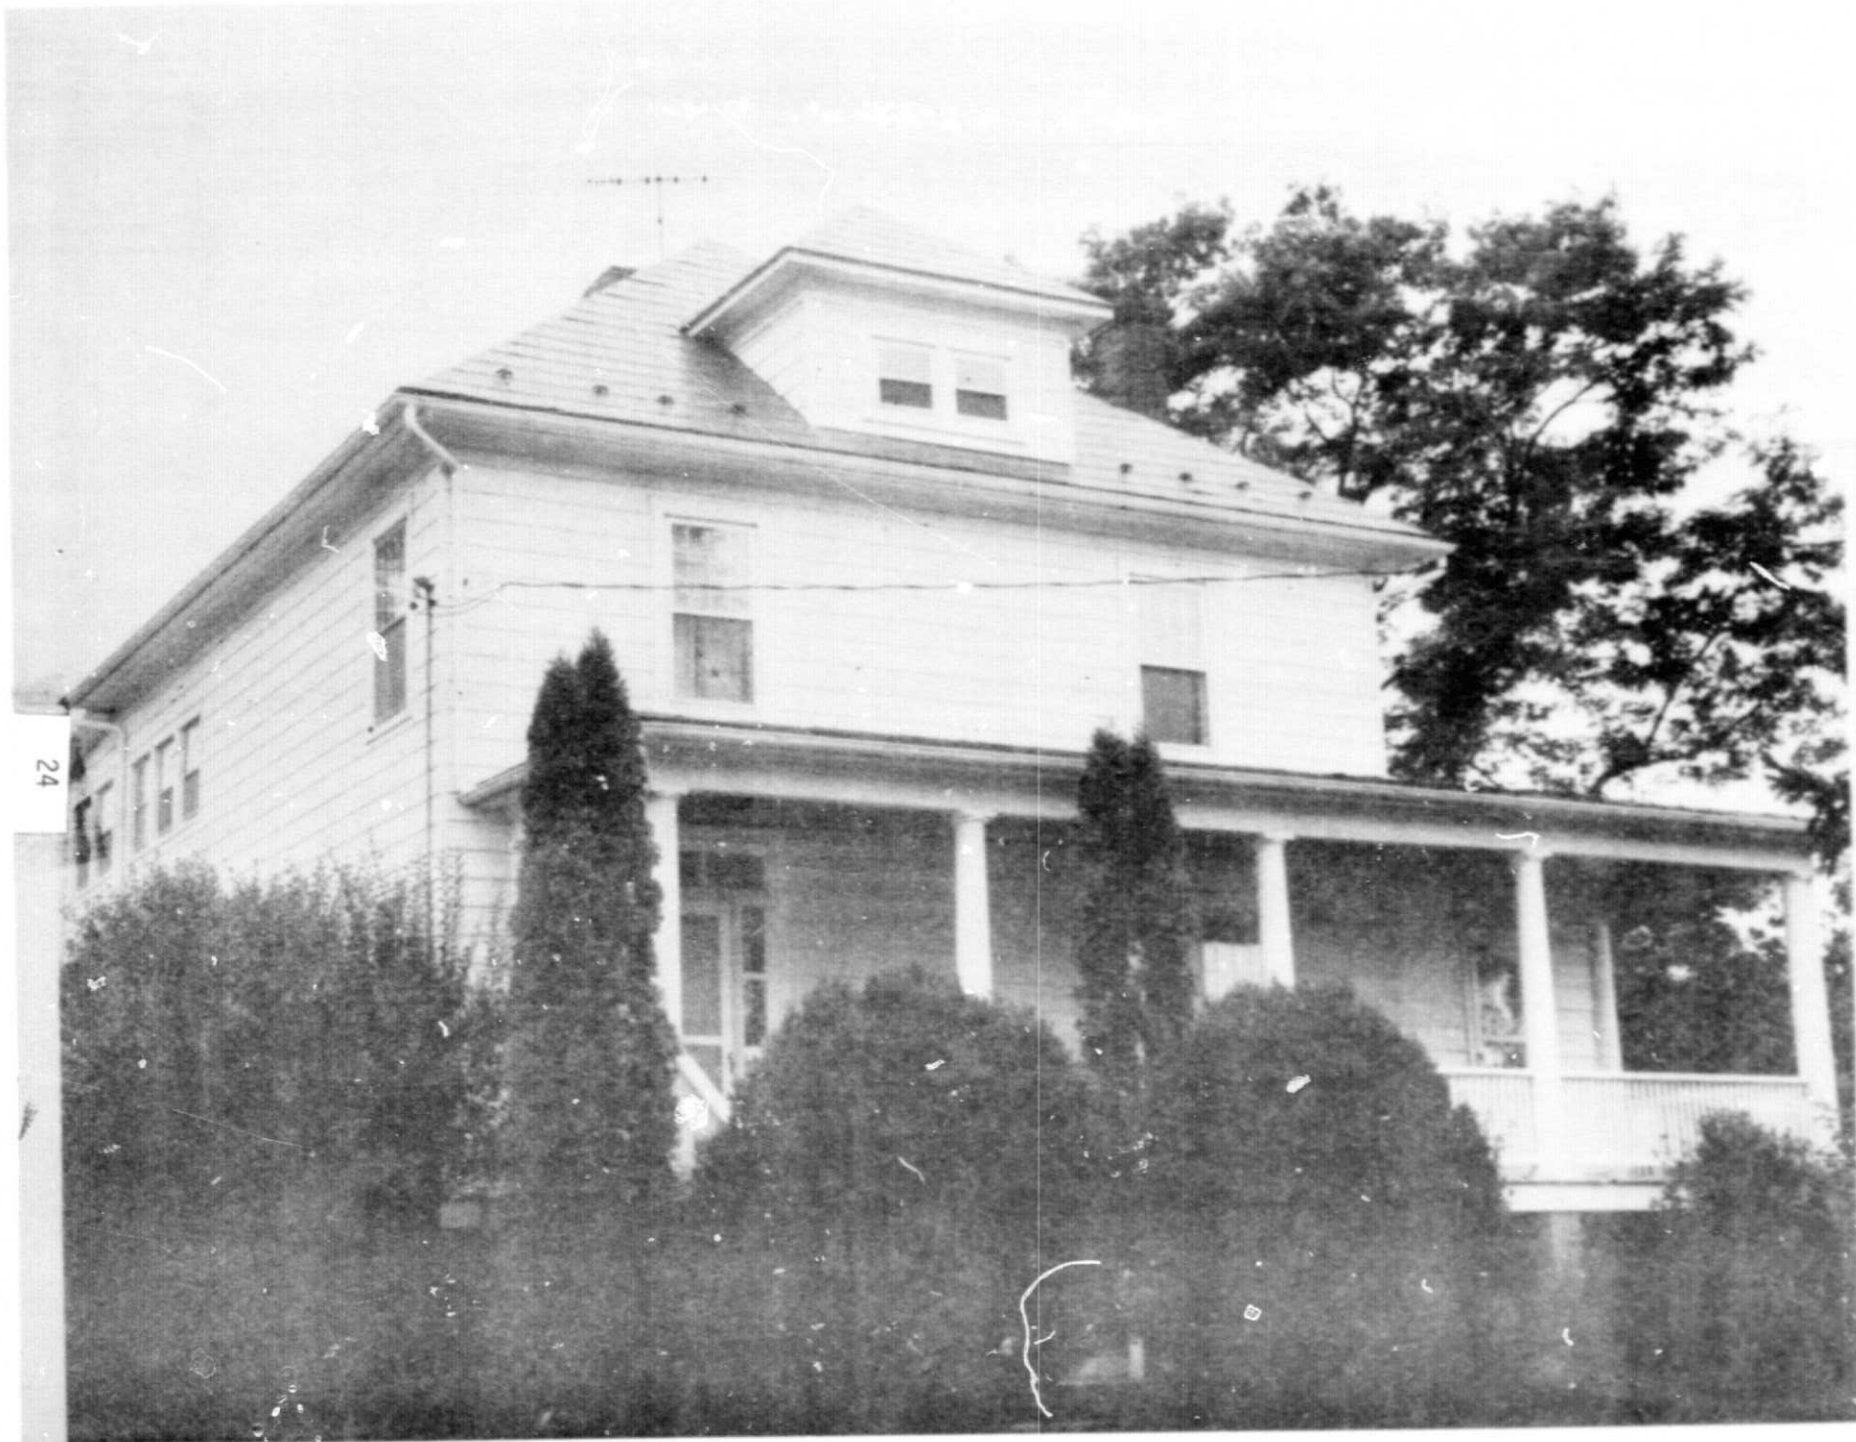
Figure 2(a). North elevation view of test structure 2.

Test structure 2.- Figure 2(a) is a picture of the north side (front) of the 60 year old two-story frame structure situated on a north facing slope of a knoll in the rural village of Barnesville, Maryland. A sketch of the plan view of the house is provided in figure 2(b). The house is of wood frame construction with aluminum siding over wood clapboards. The interior wall studs of the house are covered with lath and plaster. The original plaster has since been covered with wallpaper. As was the case with test structure 1, information was received from the owner which determined that portion of the house which appeared to receive most of the Concorde exposures. Subsequently, the dining room was chosen as the room for locating the two accelerometers. Figure 2(c) shows the location of the accelerometer on the south wall of the dining room, behind the china closet. Another accelerometer was centered on the outside of the south dining room aluminum framed storm window as shown in figure 2(d). The storm window was of single thickness construction and measured 71.1 cm by 76.2 cm and covered a window with 16 sashings. Two microphones were used to measure inside and outside

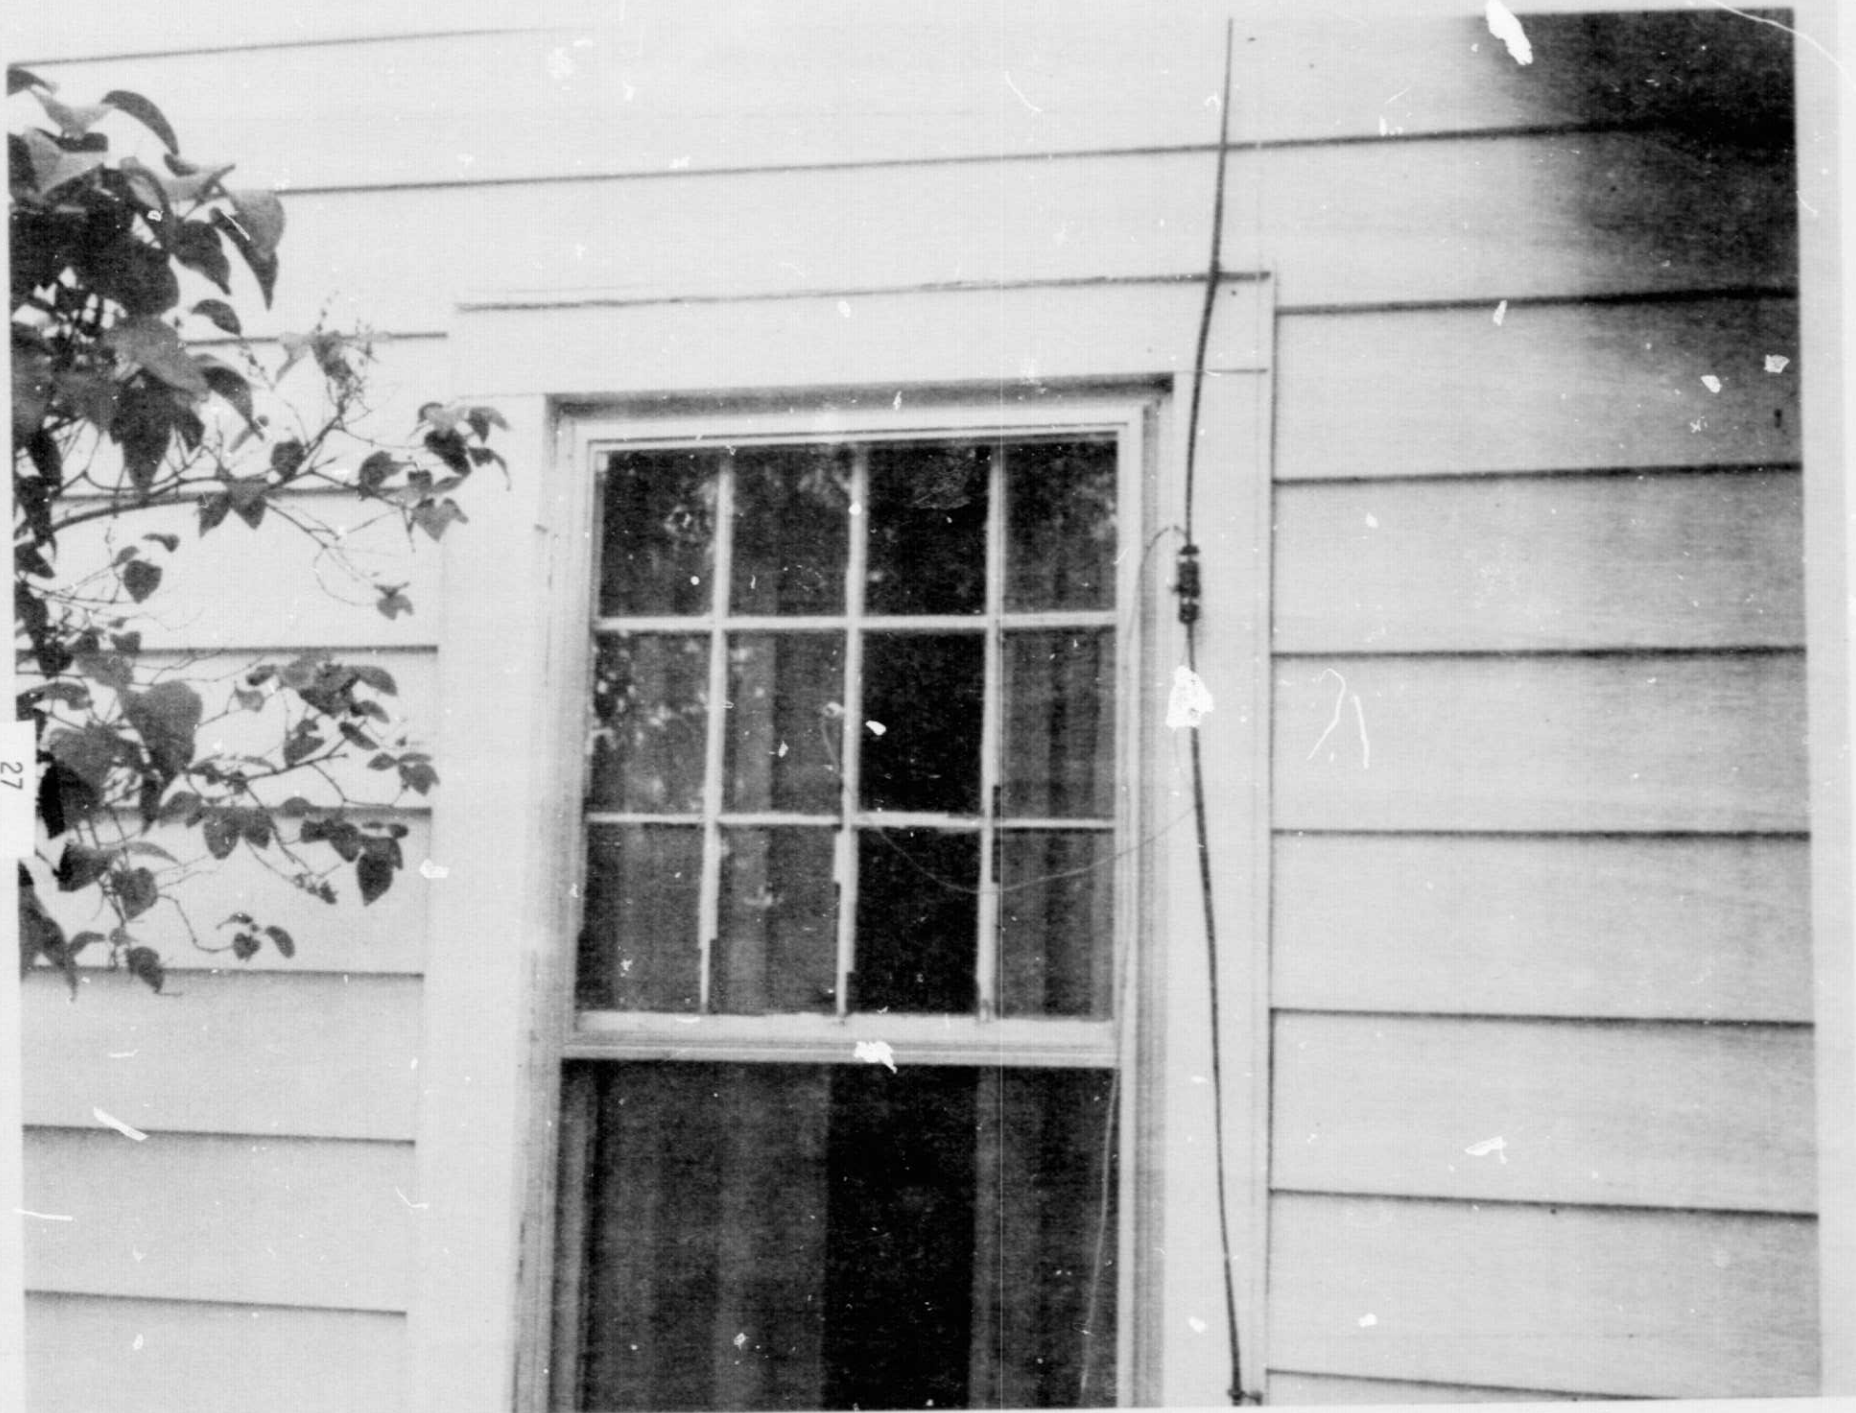
Figure 2(d). Location of accelerometer for window vibration measurements. Site 2.

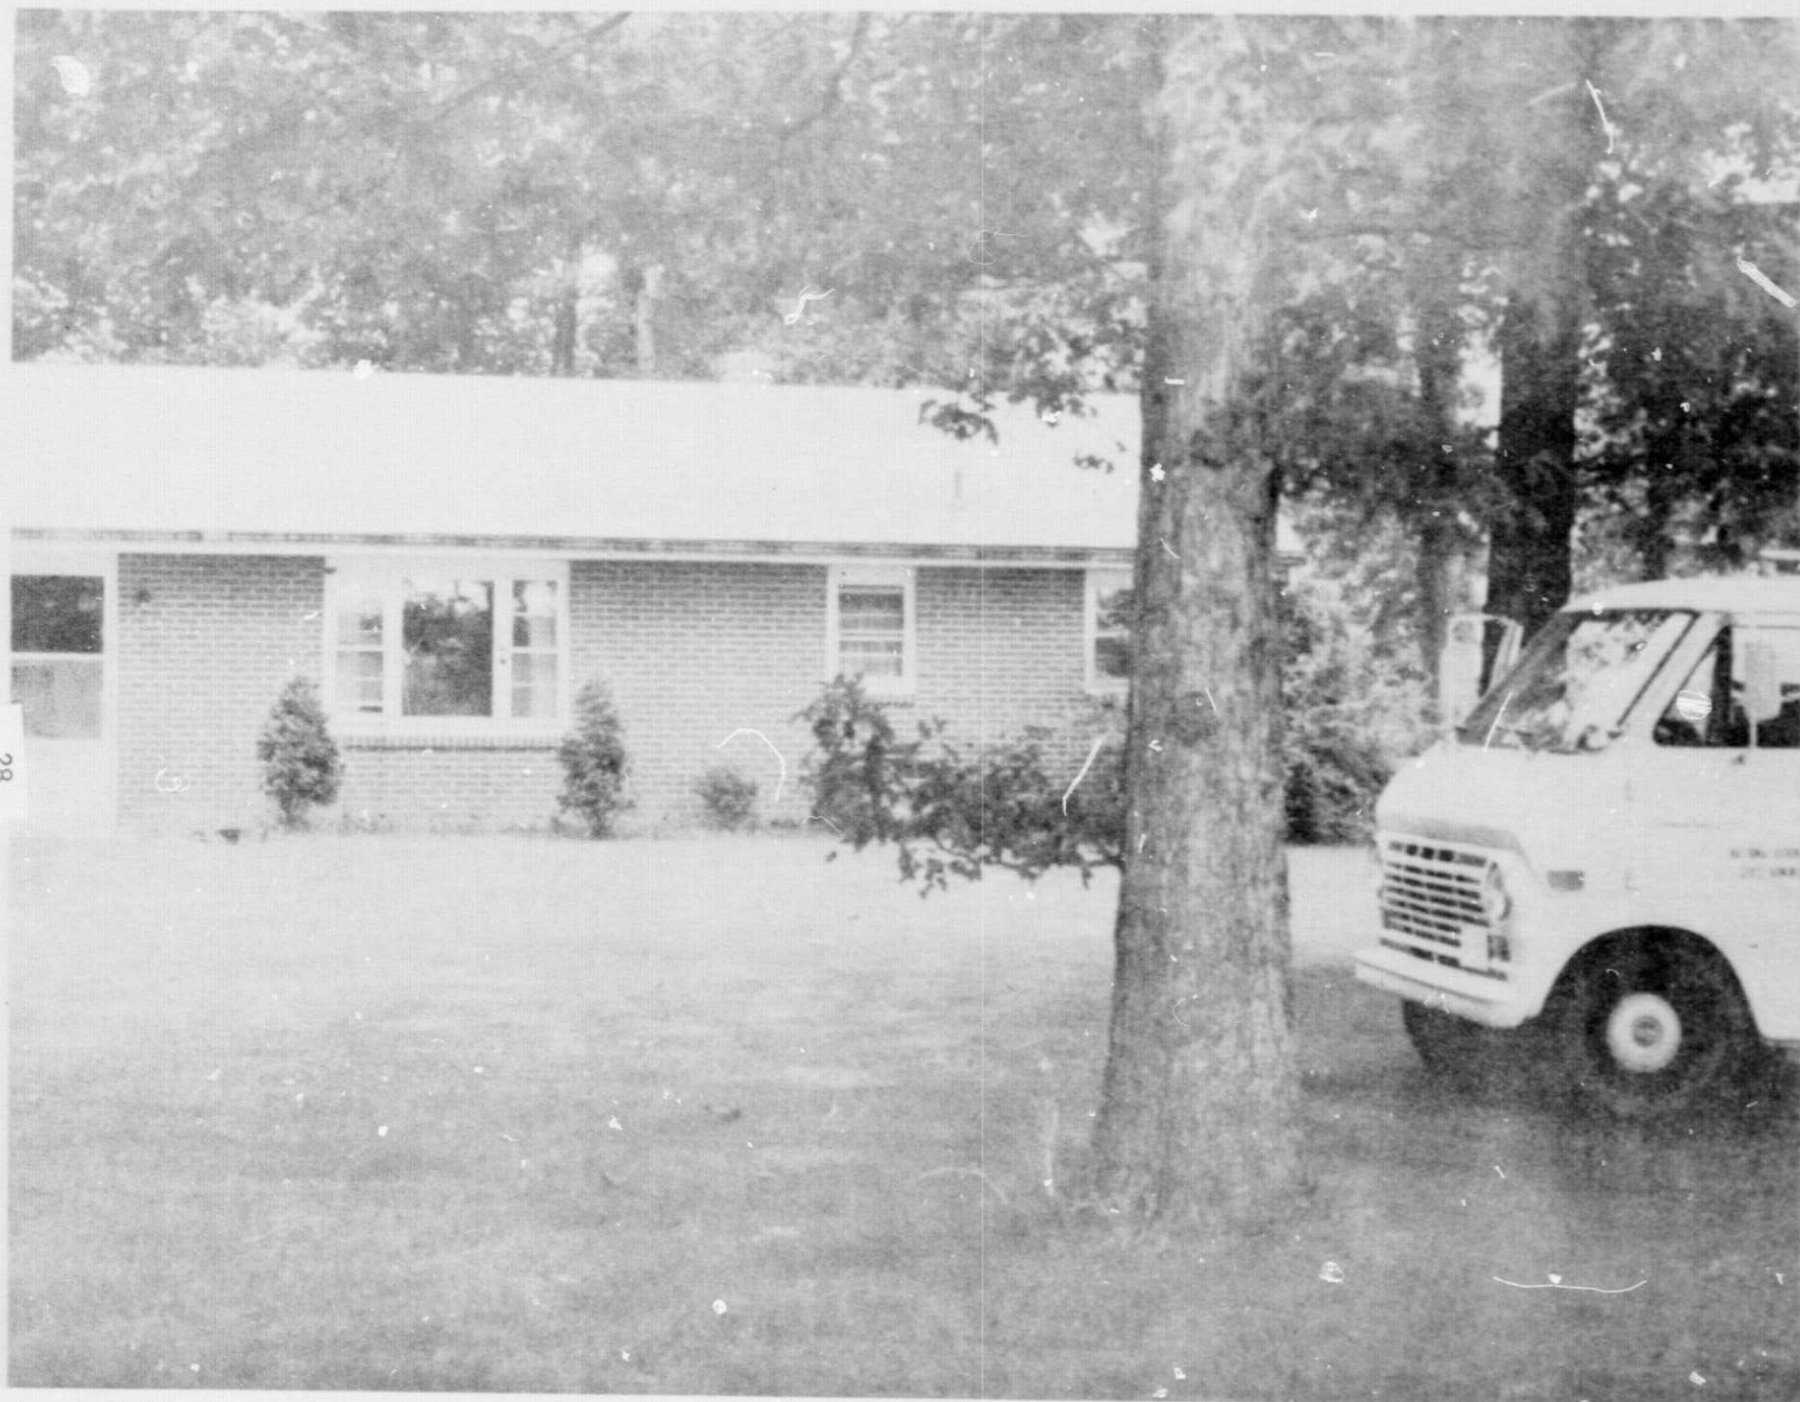
Figure 3(a). West elevation view of test structure 3.

Test structure 3.- Figure 3(a) shows the west side of the one-story house located on relatively level terrain in Dickerson, Maryland, and used as test structure 3. Figure 3(b) is a sketch of the plan view of the residence. The house is of typical wood frame construction and faced with brick veneer. The interior walls are covered with wood paneling. Because the owner indicated that the west side of the house received the most exposure to Concorde overflights, the test instrumentation was located in the living room of the house. Figure 3(c) shows the location of the accelerometer as it was positioned on the west wall of the living room. Another accelerometer was centered on the outside of the aluminum framed storm window on the west living room wall as shown in figure 3(d). The storm window was of single thickness construction and measured 78.7 cm wide by 129.5 cm long and covered a picture window of equal dimensions. Two microphones were used to measure inside and outside sound pressure levels and were located in the living room near the west window and near the (west) yard in a vacant field which was clear of trees.

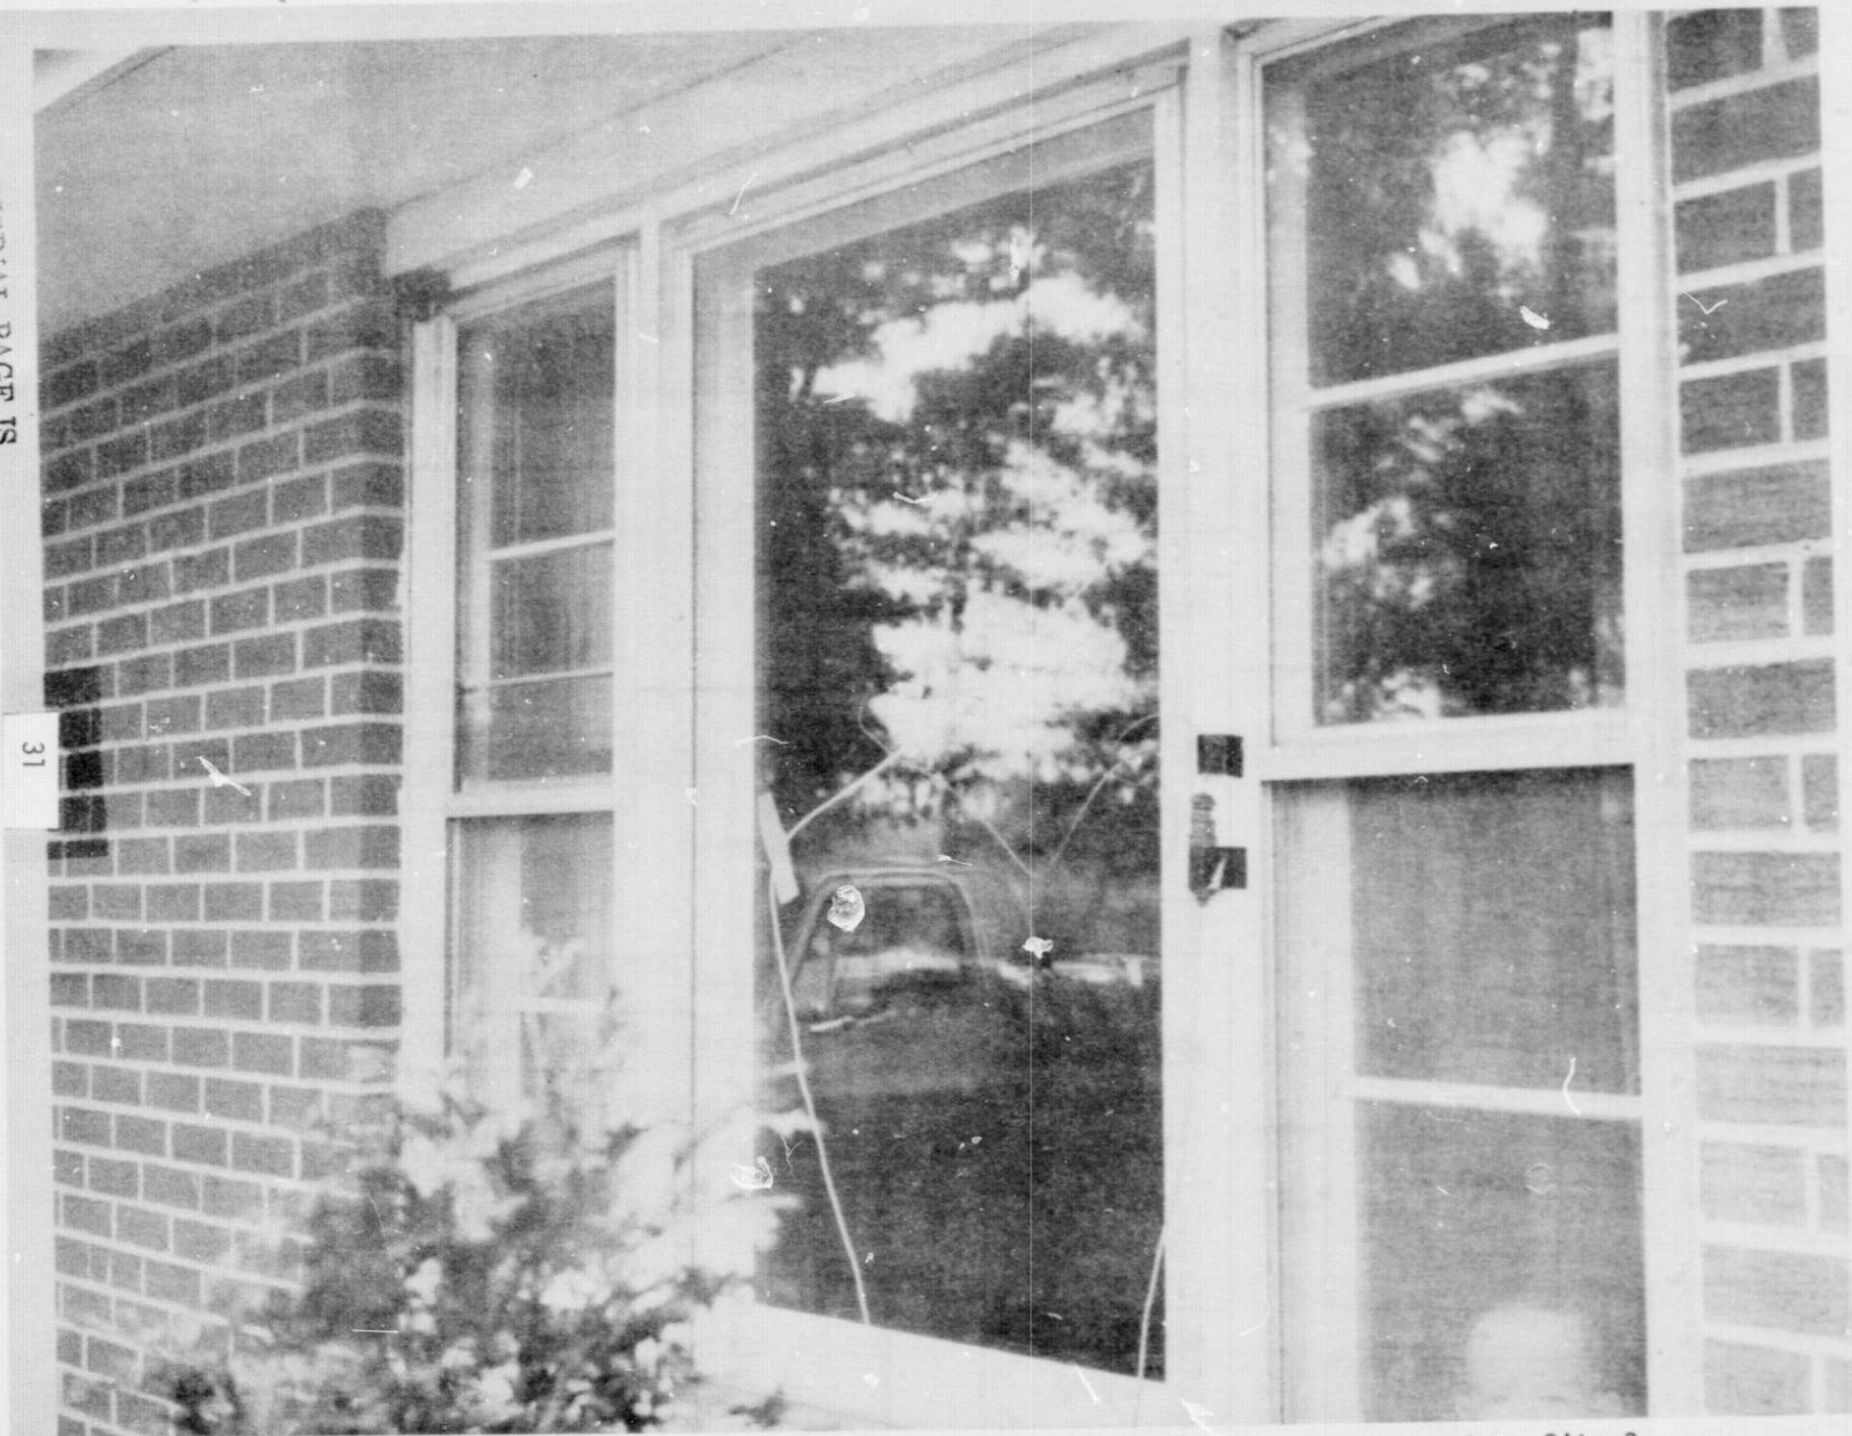
Figure 3(d). Location of accelerometer for window vibration measurements. Site 3.
